MEMO

To: Rick L. Bousquet, Liollo
From: Dorothy S. Krotzer, BCA
Date: 5/5/09
Subject: Fort Sumter National Monument

The following is a summary of immediate observations and recommended "next steps" related to the brick masonry of Fort Sumter National Monument, as identified during my site visit and meeting with the project team on 4/21/09-4/23/09. Members of the "project team" include the NPS staff of Fort Sumter National Monument, Liollo Architecture and BCA. The intention of this memo is to provide a prioritized course of action for the maintenance of the brick masonry of the fort, including the development of an appropriate restoration mortar for the site. The observations listed below will also inform BCA's proposal for additional consulting services.

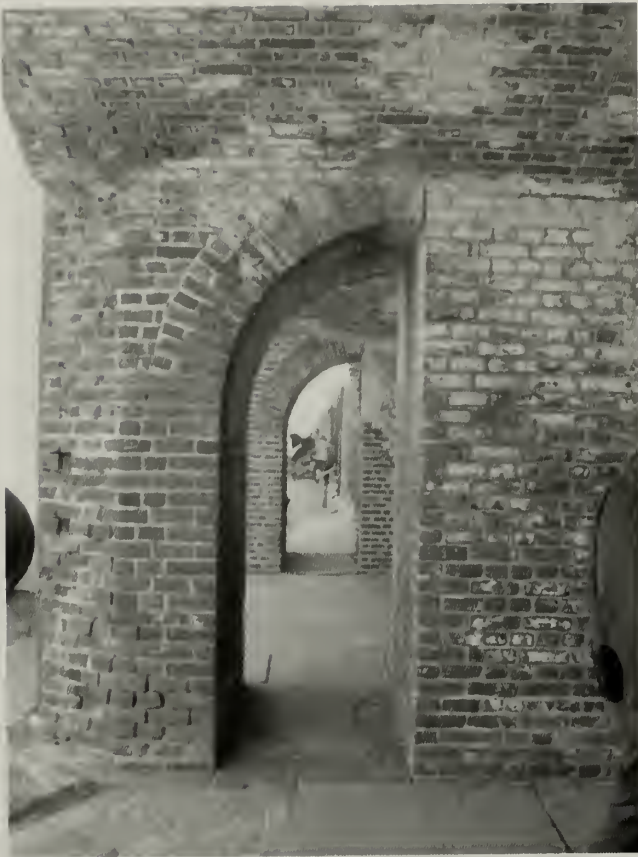
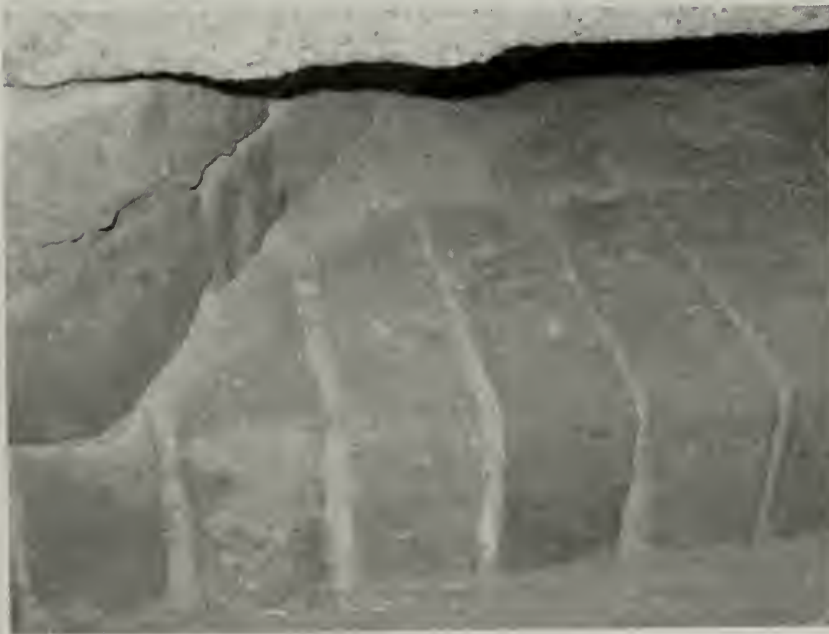
Images 1 and 2. Fort Sumter, April 2009. The first tier casemates contain areas of relatively intact interior brickwork and mortar. These brick represent the original appearance and condition of the Carolina Grey bricks.

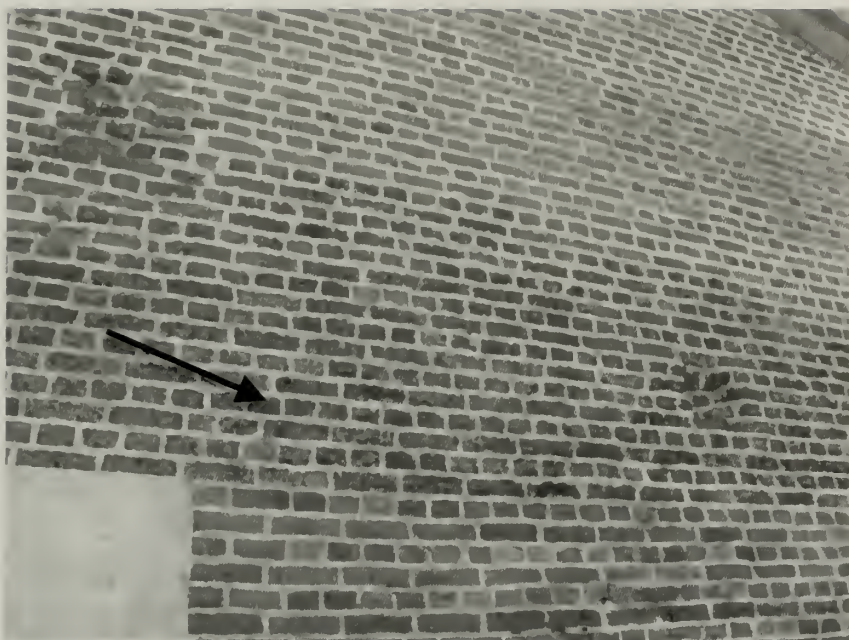
Image 3. Fort Sumter, April 2009. North elevation, showing example of modern re-pointing and condition of brick. Note more deteriorated band of brick at bottom center.

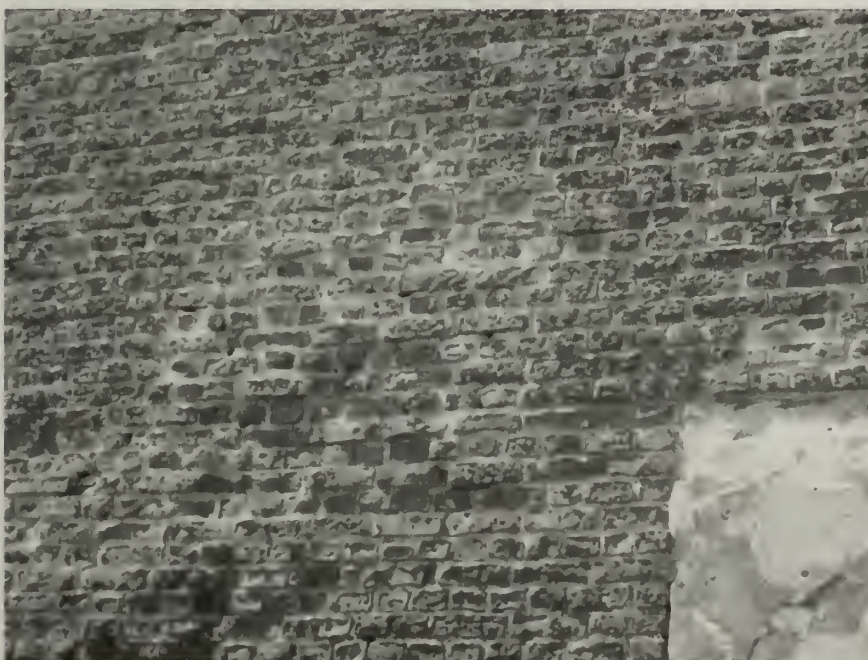
Image 4. Fort Sumter, April 2009. East elevation, detail of brick condition. This wall receives more wave impact and saturation with sea water than others and the brick is subsequently more deteriorated.

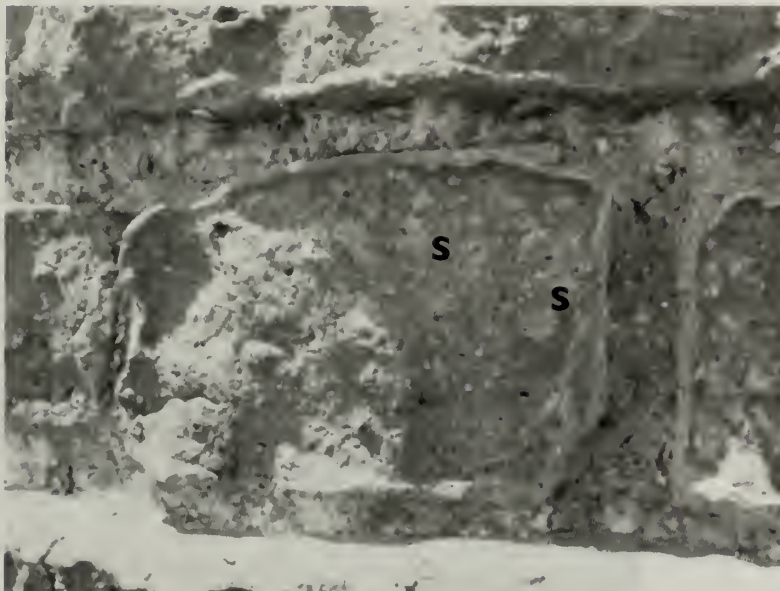
2. Currently, the brick exhibits a wide range of conditions, most pronounced when comparing the interior and the exterior surfaces. The more protected interior brick is essentially intact, with the exception of a few areas where the brick was damaged in the Civil War or in areas where it is exposed to exterior conditions (i.e. adjacent to window openings, water run-off or rising damp). The historic (possibly original) mortar is fairly intact in these interior surfaces as well, particularly inside the casemates. The exterior brick walls are in far worse condition, with what appears to be extensive alveolar damage resulting from wind erosion. The majority of the brick has lost its fire skin, a condition that exacerbates the deterioration of the more vulnerable brick interior. In several locations, entire bricks have been lost from the outer wythe of the exterior wall. The worst areas in terms of overall brick damage were located on the east, southwest and west walls. The east wall in particular is experiencing active deterioration that is visible to the eye. Formation of salt crystals on the face of the brick are generating new, small spalls and causing active loss of material.

Image 5. Fort Sumter, April 2009. East elevation, example of typical brick deterioration on this elevation. Note presence of white salt crystals on surface (S) and subsequent small brick spalls, as well as the difference in rate of deterioration of brick fire skin versus interior.

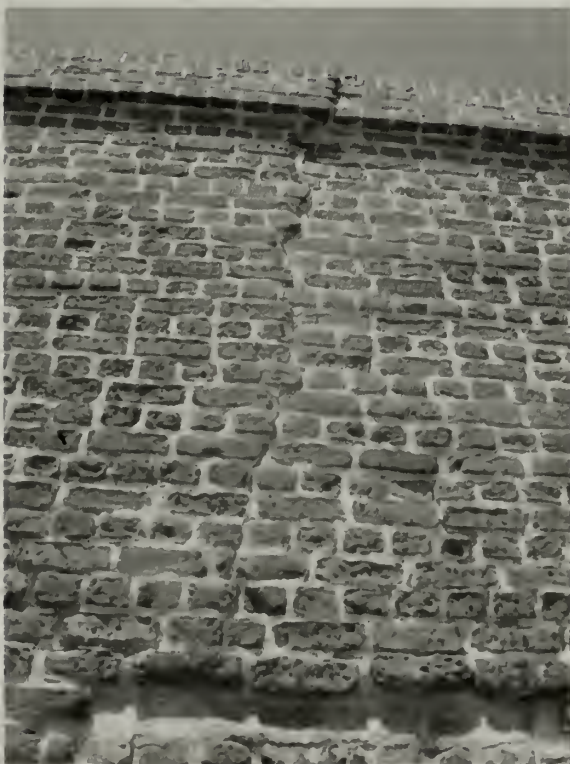
Image 6. Fort Sumter, April 2009. Southwest elevation, area of structural crack.

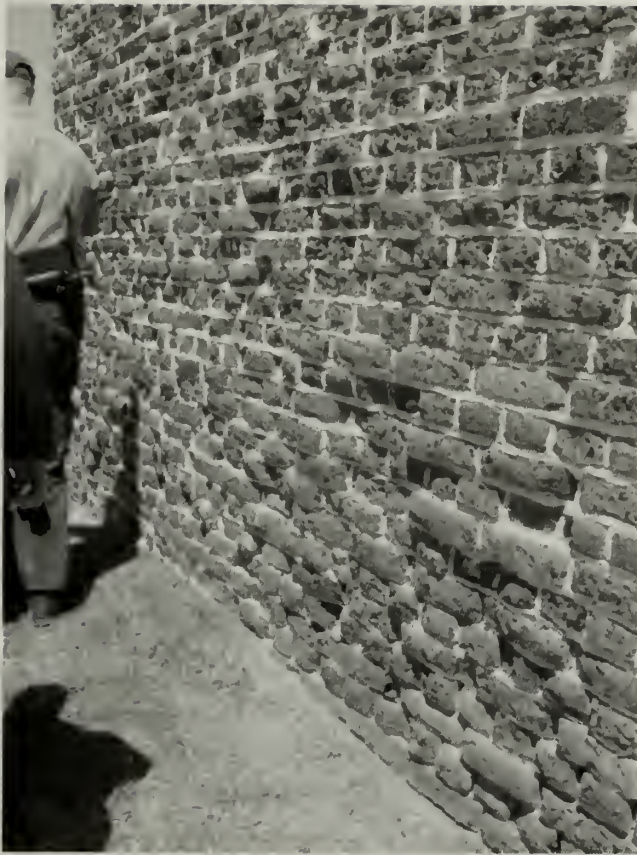
Image 7. Fort Sumter, April 2009. West/Northwest elevation, area of distinct alveolar (wind-driven) erosion.

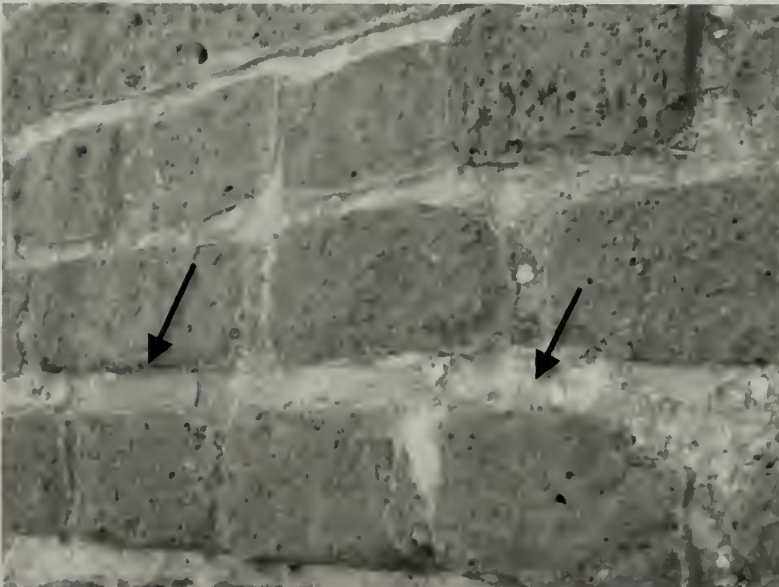
Image 8. Fort Sumter, April 2009. East elevation, mortar failure.

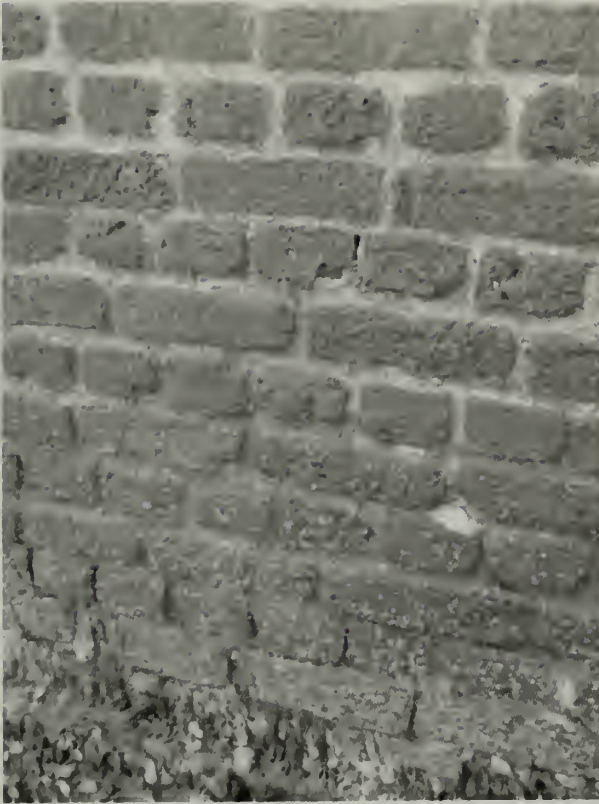
Image 9. Fort Sumter, April 2009. East elevation, condition of mortar (presumably historic) at base of wall with constant exposure to water, particularly at high tide.

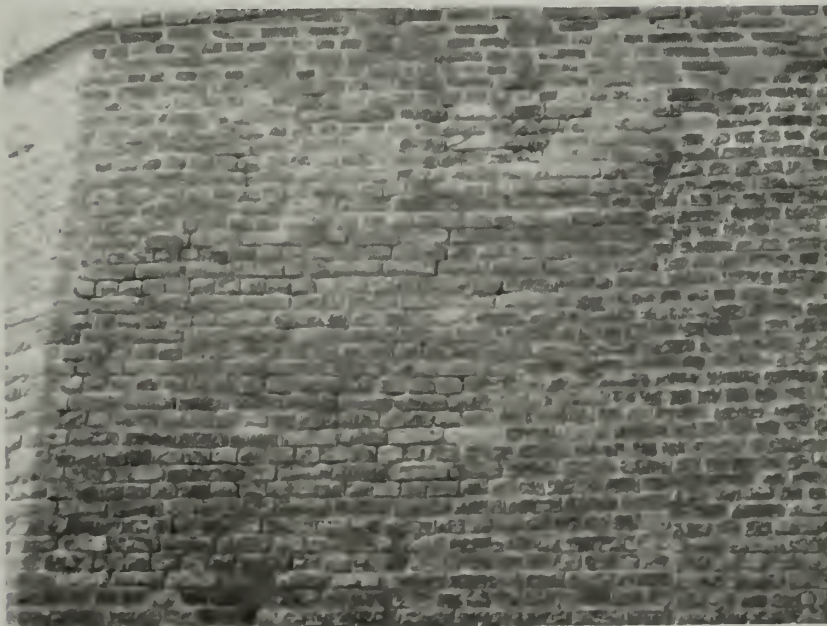
Image 10. Fort Sumter, April 2009. East/Southeast elevation, area of open mortar joints.

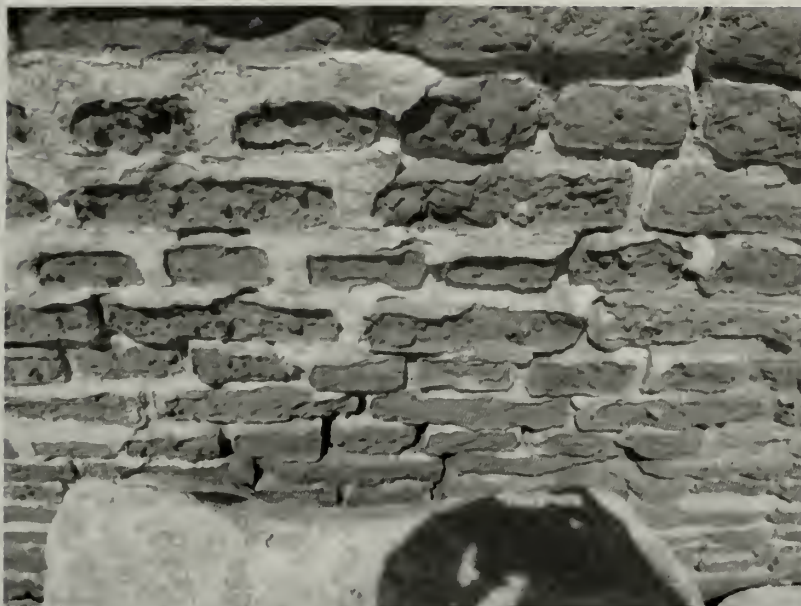
Image 11. Fort Sumter, April 2009. Exterior scarp wall, an area of prior re-pointing campaign based predominantly on Portland cement. Note condition of surrounding brick, it has weathered at a more advanced rate than the mortar, producing a characteristic “honeycomb” effect.

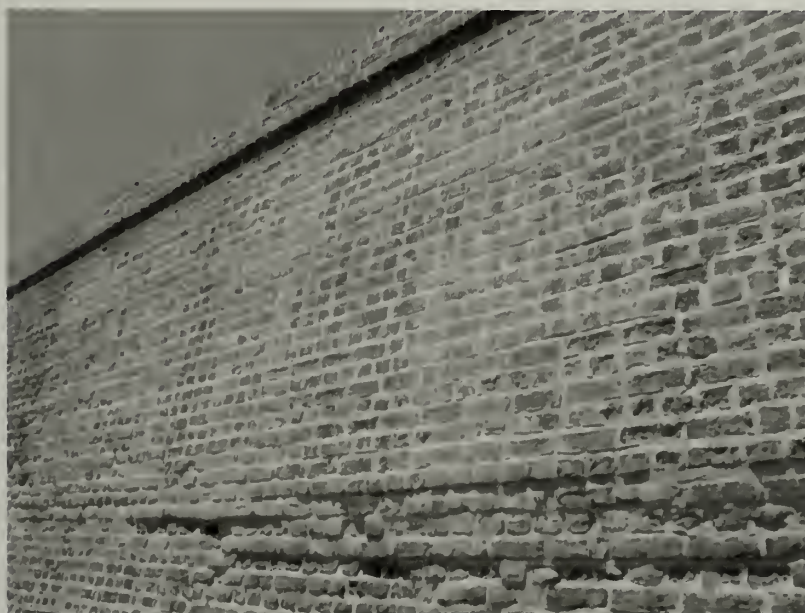
Image 12. Fort Sumter, April 2009. Southeast Elevation, area re-pointed in 2008 using Rosendale natural cement gauged with hydrated lime. The streaking on the wall is most likely due to the lime component of the mortar washing out of the mortar prior to achieving full carbonation.
